# River Action Plan for the Sabina, Abba and Ludlow Rivers

Volume 3. Maps and Recommendations for Ludlow River and Tiger Gully

Prepared for the Geographe Catchment Council - GeoCatch and the Vasse-Wonnerup Land Conservation District Committee

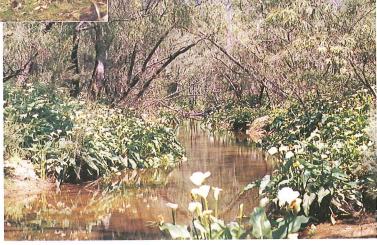
B3 grade foreshore on the Abba River. Weeds dominate the understorey, restricting the regeneration of native species.

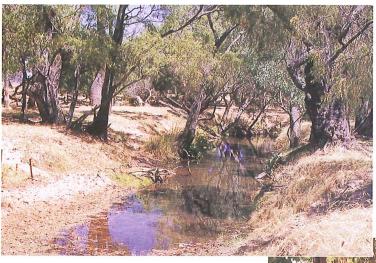
C1-C2 grade foreshore on the Sabina River. Trees remain though there is little evidence of regeneration. The shallow-rooted weedy understorey provides no support to the soil, making the banks vulnerable to erosion.
